**51st Annual Meeting of the Civil Engineering Society of Japan
(September 1996)**

Repairing of Heavily Cracked Reinforced Concrete Bridge Deck Slab From Underside

Shigemichi Mori, *The Construction Bureau of Chubu District, The Ministry of Construction*
Yuzuru Kuramoto, Minoru Emilio Takagi, *Japan Xypex Inc.*
Moichi Horie, *Aichi Institute of Technology*
Shushi Tanimoto, *Tenox Inc.*

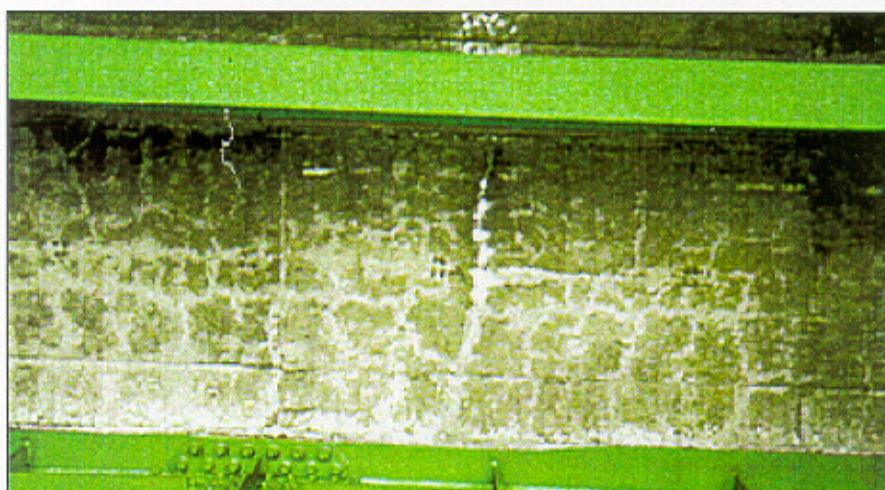
The Hokutoh overpass bridge on National Route 23 was built in 1972. There has been significant heavy traffic, with 40,000 large-size cars representing about 40% of the total traffic crossing this bridge every day. Many overloaded vehicles are also utilizing this bridge. Therefore, many cracks measuring 0.1 to 0.2 mm in width have appeared in all directions on the concrete deck slabs. Depending on the location, a significant amount of efflorescence of lime is observable and indicates water leakage. Photo 1 is an example of the cracks on the underside of the concrete deck slab.

Photo 1: Evidence of cracking in concrete on underside of the deck slab

1. Clean up stains and remove any loose material or dust from the underside surface of the concrete deck slab using a high-pressure water blaster.
2. Spray the accelerative curing agent Xypex Gamma Cure (XG) on the surface.
3. Mix the powder crystalline waterproofing agent, Xypex Concentrate, with water as per the specified proportions. Apply the resultant slurry mixture using a brush (by 1.2 kg/m² average) on the deck surface and leave for 10 months.

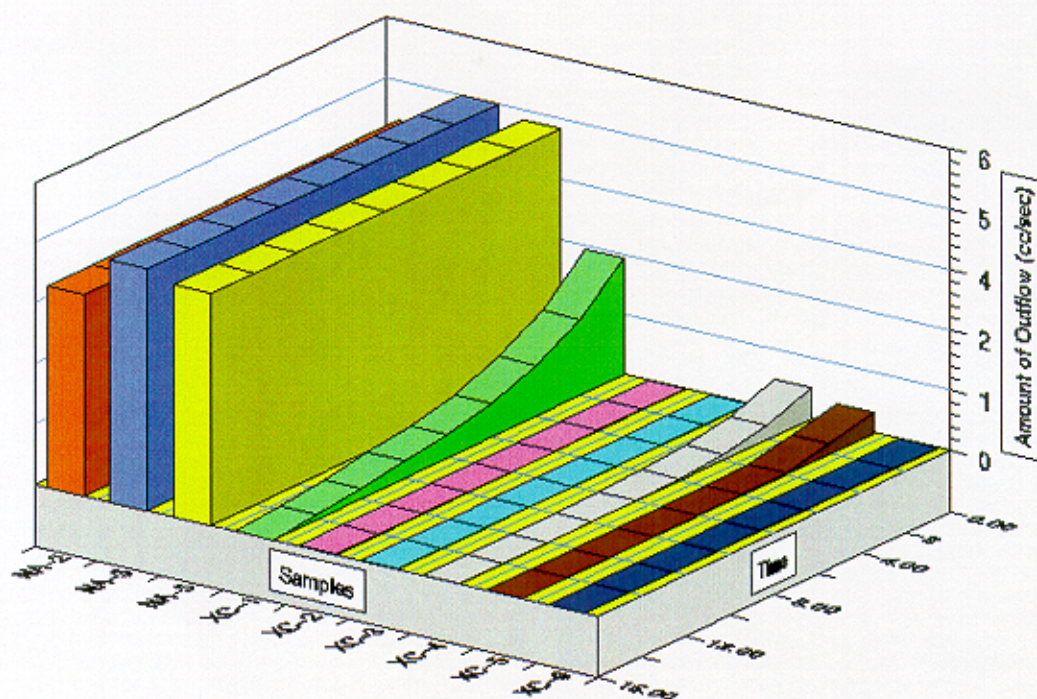
Figure 3: Change in Amount of Outflow with Time

Test results shown in Table 1 and Figure 3 indicate the change in outflow from the test samples at 2 hour intervals as well as the initial amount of outflow from samples.

In the group of samples to which Xypex Concentrate was applied, there are some specimens with initial leakage but the waterflow gradually decreases and finally ceases.

In contrast, the group of untreated samples had an initial outflow reaching almost 5 cc/sec (300 cc/min) therefore it was difficult to continue the succeeding measurements. At that point, it was assumed that the amount of outflow was constant.
