REPORT TITLE:	DURABILITY PERFORMANCE OF CRONULLA MARINA A CONCRETE SLAB MODIFIED WITH XYPEX WATER-PROOFING ADMIXTURE		
CLIENT:	Xypex Australia		
REPORT AUTHORS:	Dr Zhen Tian Chang		Marton Marosszeky
REPORT DATE:	16 July 2013	FILE REF:	Document BCRC0372
SUMMARY	<p>The condition of a concrete deck slab modified with Xypex admixture was investigated after nearly 19 years exposure to a severe marine environment at the Cronulla Marina. The slab was in good condition, free of concrete spalls, cracks and rust stains.</p> <p>A concrete core sample was taken from the slab and was analysed in a NATA accredited laboratory for the chloride contents at 5 average depths of 3, 10, 20, 30 and 40mm. The results clearly showed that the chloride content in the slab drops rapidly with the slab depth beyond the first 15mm. The chloride diffusion coefficient calculated from Fick's second law was found to be 0.080×10^{-12} (m²/s), which is a very low value compared to those of normal concretes described in the literature. Based on this chloride diffusion coefficient and Fick's second law, the predicted time for the chloride level in the slab to reach the critical threshold level of 0.4% by weight of ceme

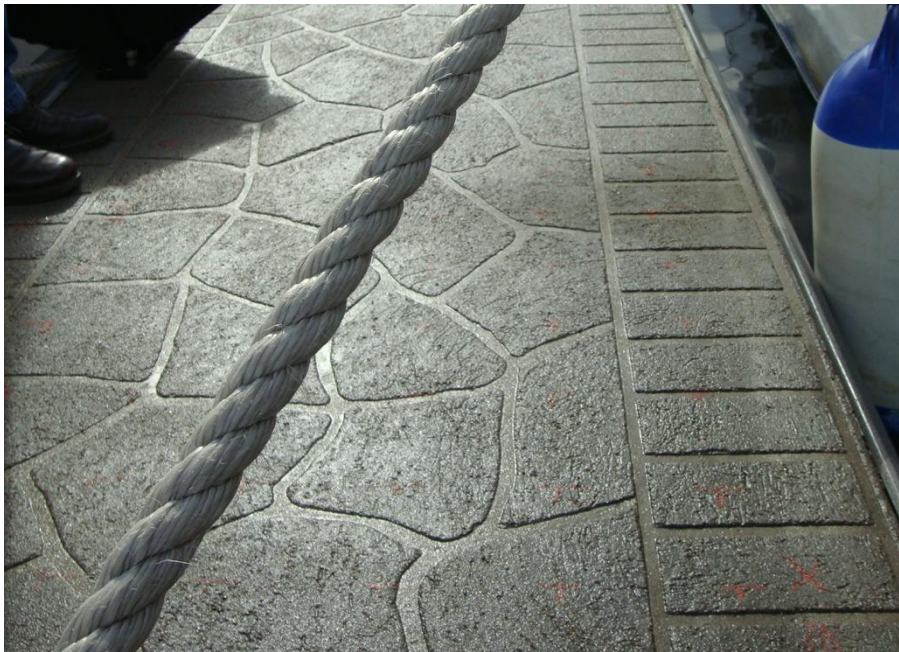
A detailed investigation was carried out on a deck slab 12 m long, 1.2 m wide and 100 mm thick at the outer end of the jetty. The slab was prestressed using longitudinal wire strands. During the visual inspection we looked for signs of corrosion induced damage and could find none, there were no rust stains or spalls (see **Photos 2 and 3**).

Photo 3: A closer view of the jetty slab top surface condition

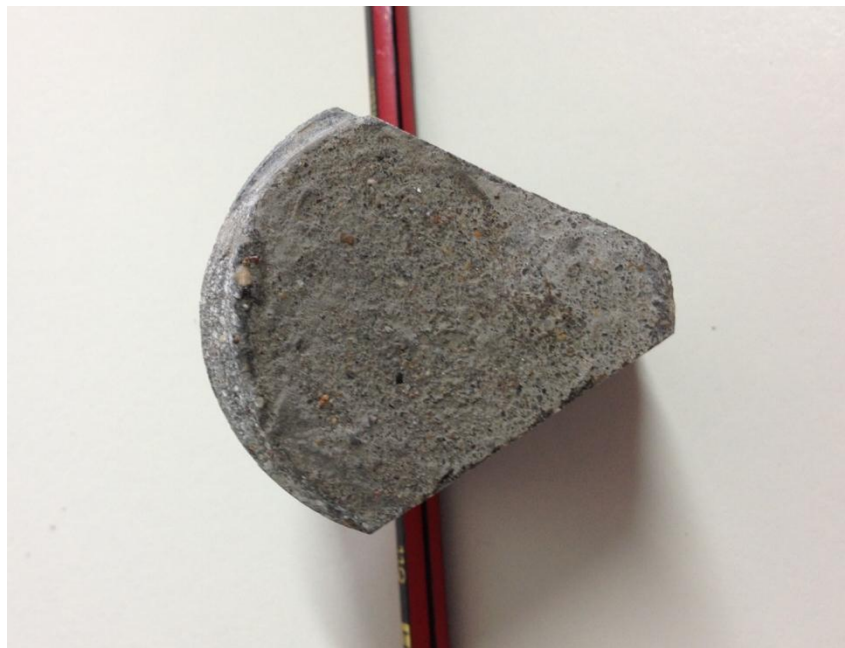
A concrete core was extracted within 1 m from the outer end (see **Photo 4**); at this location the structure is exposed to wind-swept waves and salt laden aerosols. The core was extracted between painted patches of the Faux Brick pattern in order to minimize any effect of the Faux Brick materials on the results. Two Faux Brick patches overlapped the edges of the core, these portions were sawn off (see **Photo 5**) before materials were sampled for the analysis of the chloride content in the core.

Photo 5: Core top surface after removing Faux Brick on two edges

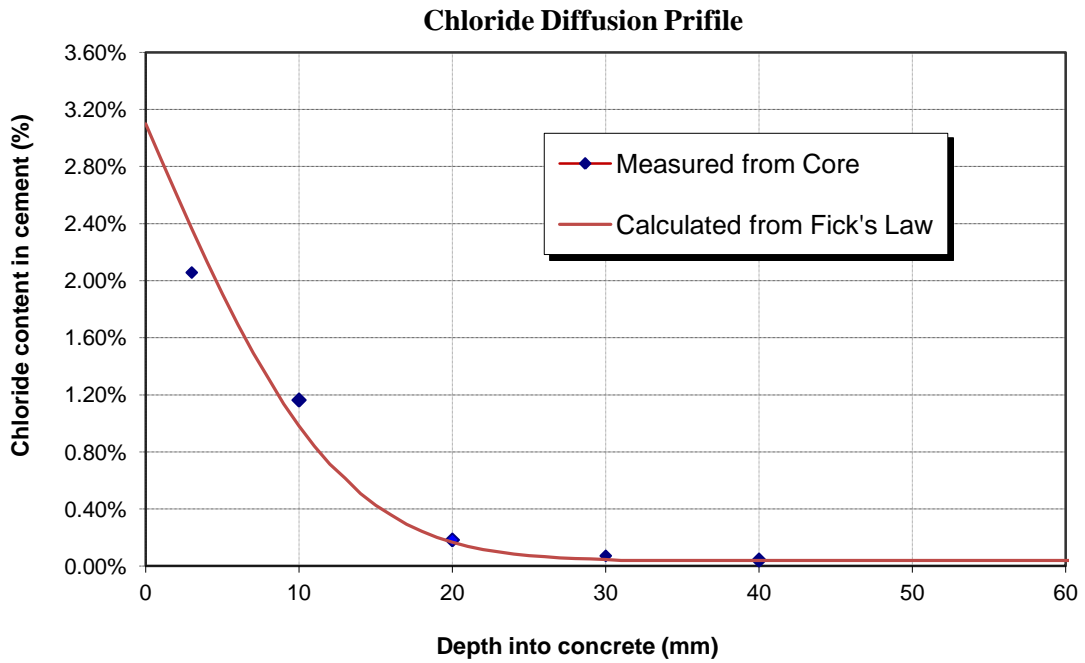
To further quantitatively evaluate the resistance of concrete against chloride penetration, the chloride diffusion coefficient in the core was calculated using Fick's second law of diffusion. In **Fig. 6** the measured chloride contents in the core are plotted as "diamonds", while the theoretical curve obtained from Fick's law is displayed as the red line. This theoretical curve fits reasonably well with the measured chloride profile, and it yields an effective chloride diffusion coefficient of 0.08×10^{-12} (m^2/s). This diffusion coefficient is a very low value compared to those reported in the literature for normal concretes.

Fig.6 Measured and calculated Chloride diffusion profiles in the concrete core

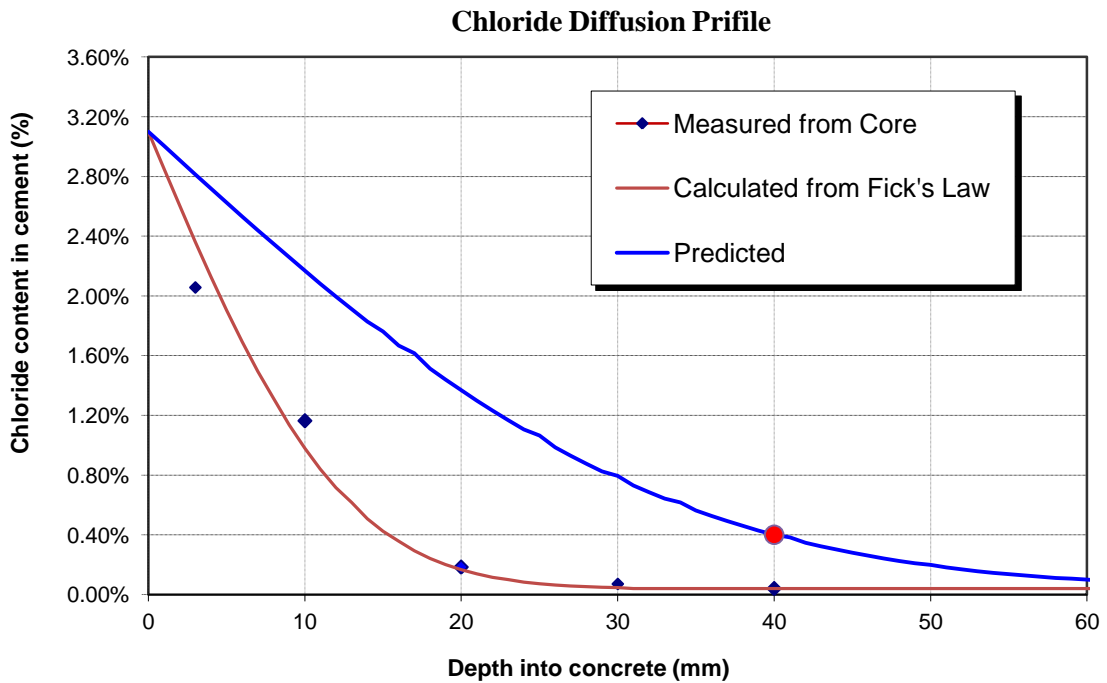
The results of this analysis are plotted as the blue curve in **Fig. 7**, the predicted critical chloride concentration of 0.4% by weight of cement at 40 mm could be reached at an age of 129 years with the current exposure conditions. This is the time to the onset of corrosion and not to cracking resulting from corrosion as in the case referenced above.

Fig.7 Predicted "Critical" chloride diffusion profile verses the measured profile

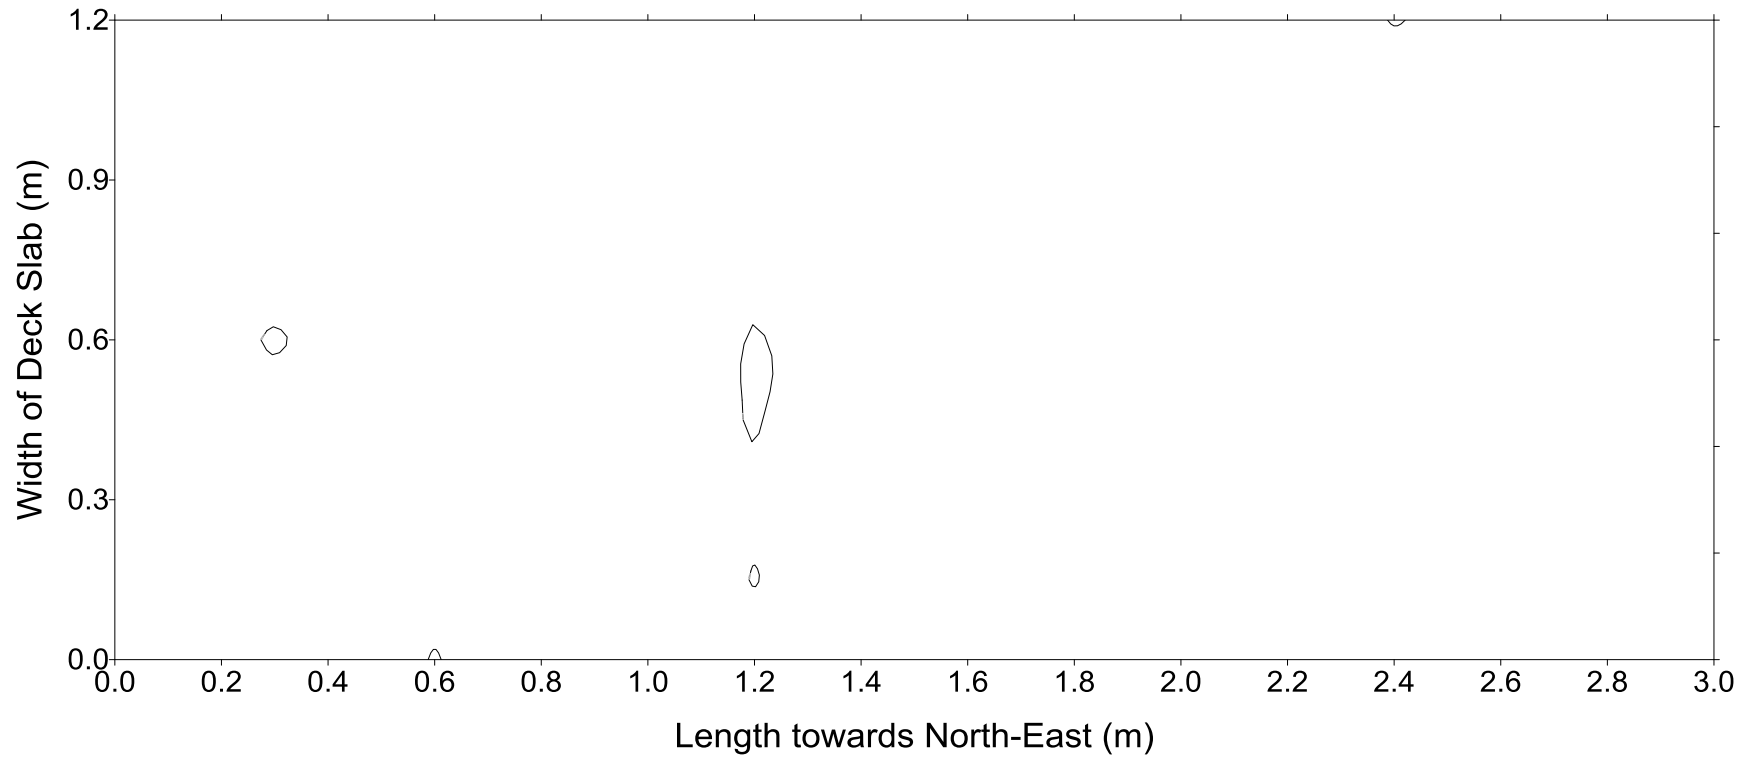
Fig. 10 plots the half cell potential curvature contour map showing locations corresponding to the potential gradients of 150 mV per metre or higher. It shows there is only one location with high potential curvature values (x = 1.2m, y = 0.5m) where the risk would be only slightly higher because there are no multi and dense contour lines around the location.

Fig.10 Half Cell Potential Curvature Contour Map over Surveyed Concrete Slab Area
