SHARP AND HOWELLS

CONCRETE INVESTIGATION – XYPEX PANEL

INVESTIGATION REPORT

FEBRUARY 2014

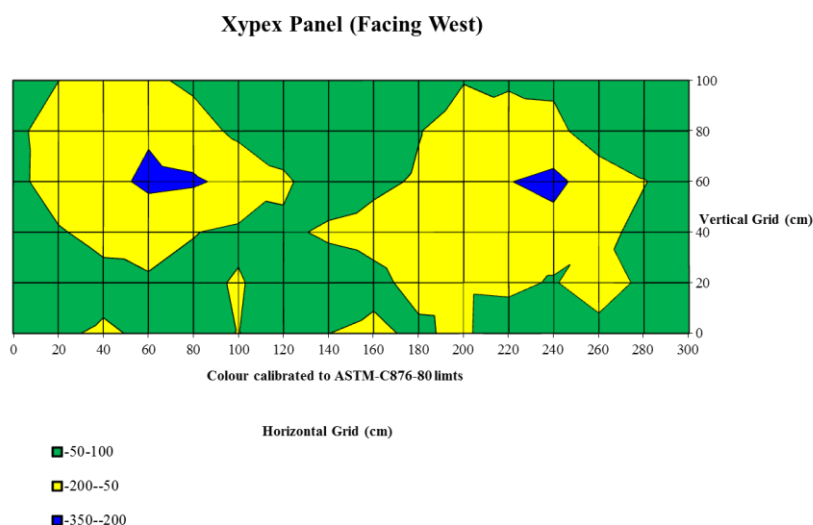
Figure 1 Xypex Panel

- Calculated Mean of the measured values: -51.6mV
- Range of measure values: -243mV to 52.9mV
- Calculated Standard Deviation of the measured values: 62.2

This analysis indicates that there are some sections of reinforcing that have a greater than 95% probability of corrosion (as identified by the blue areas (-200 to -350 mV)). These areas are at the location where the steel was exposed for the test connection. The wet nature of the exposed steel at these locations can distort the results, requiring careful interpretation.

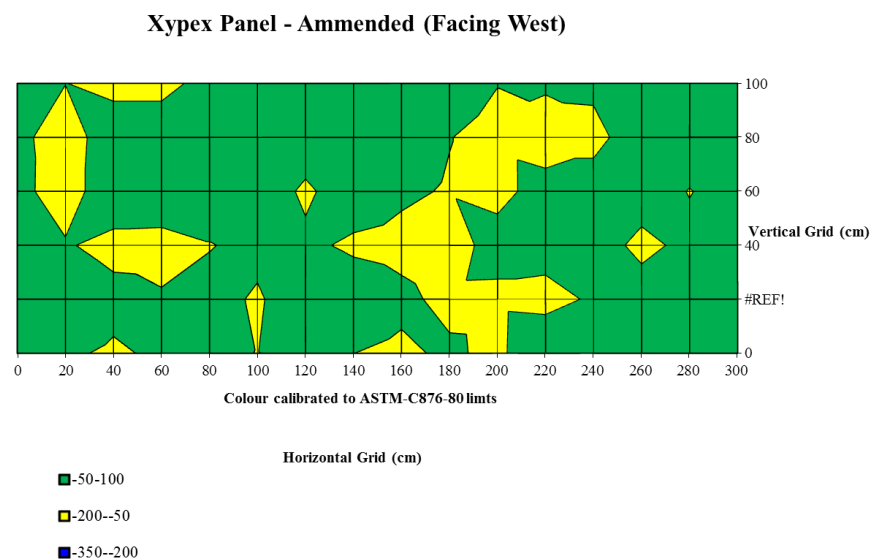
Figure 2 - Xypex Panel - Amended Values

- Calculated Mean of the amended values: -31.5mV
- Range of amended values: -105mV to 52.9mV
- Calculated Standard Deviation of the amended values: 37.8

The amended plot indicates that the majority of the reinforcing in the Xypex panel has less than 5% probability of corrosion. There are however some sections that fall within a 50% probability of corrosion (-200 to -50 mV). After amending this data set, the calculated mean value can be seen to be more positive and there is a smaller standard deviation value than the measured values. This indicates that the amended sampling has a more evenly distributed potential range.

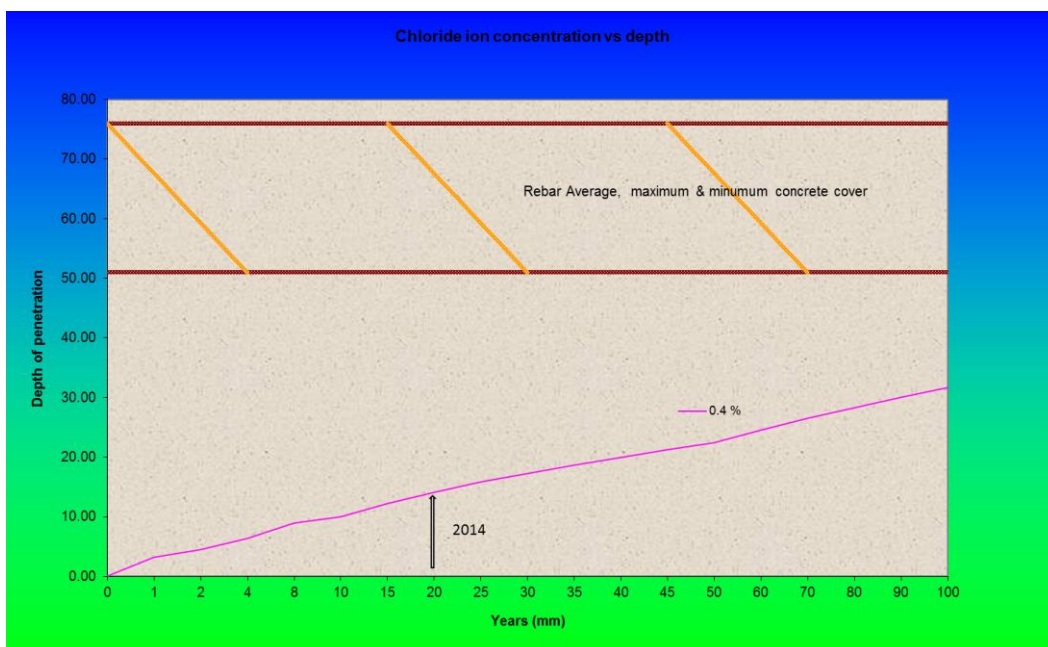
SAMPLE 1

The graph below gives an indication of the 0.4% w/w cement chloride level at concrete depth for the 1st location. The time required for the chloride levels to obtain the theoretical level of 0.4% w/w cement at reinforcement depth (51mm) as calculated by Fick's 2nd Law of diffusion, is 160 years for this location. As is shown in the graph, corrosive levels of chlorides will not be at rebar level for well over 100 years of service.

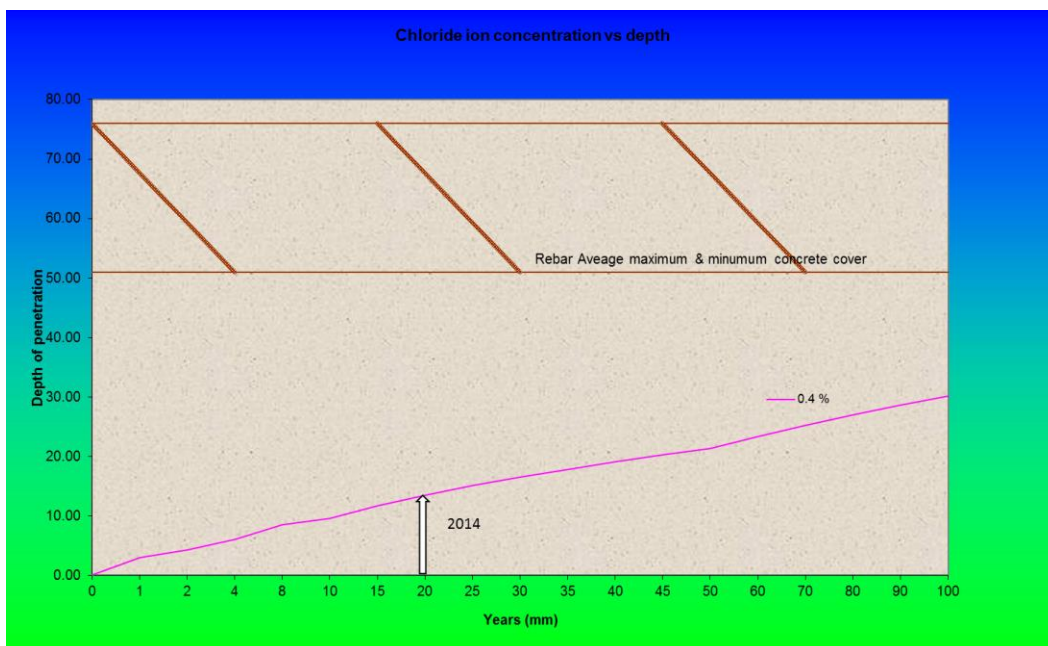
SAMPLE 4

For the 4th location results are quite similar to location 1 and 3. The time required for the chloride levels to obtain the theoretical level of 0.4% w/w cement at reinforcement depth (51mm) as calculated by Fick's 2nd Law of diffusion, is 175 years for this location Corrosive levels of chlorides will not be at rebar depth for over 100 years.

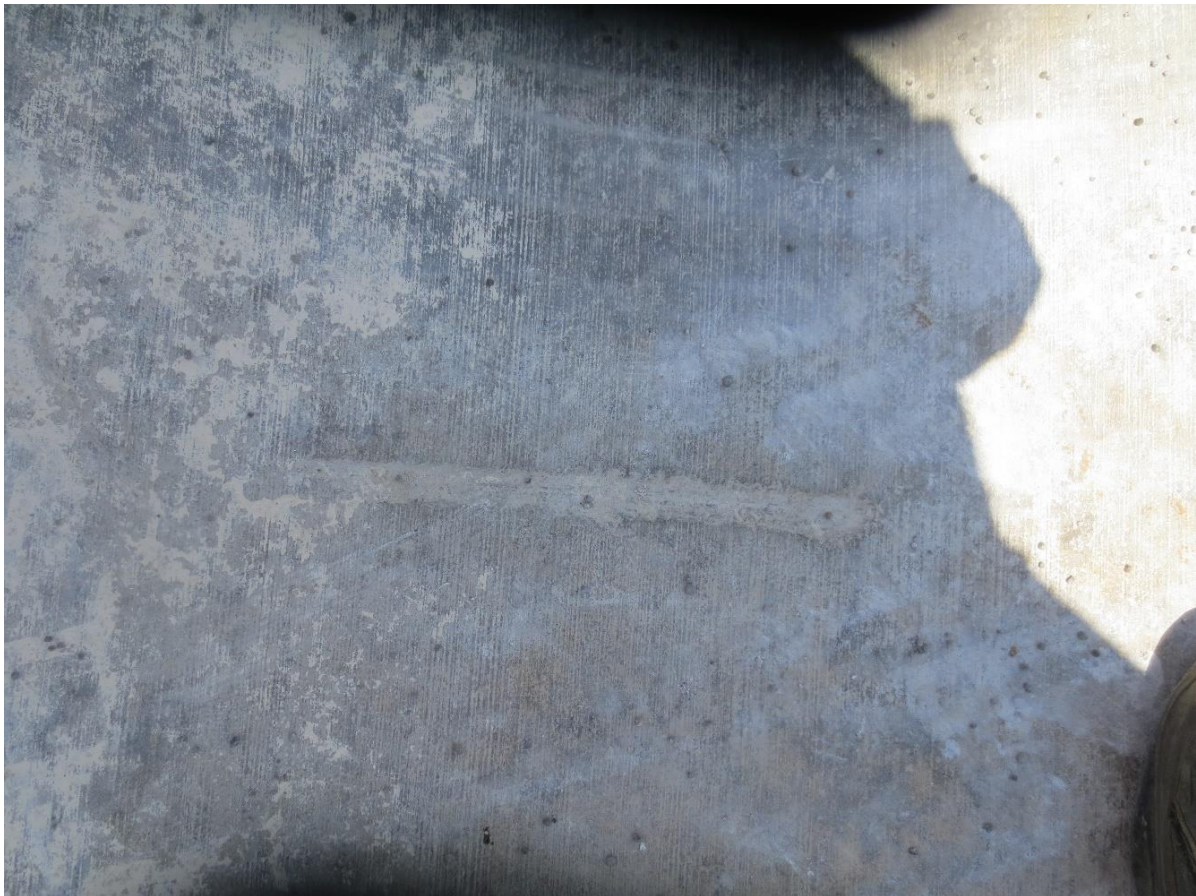
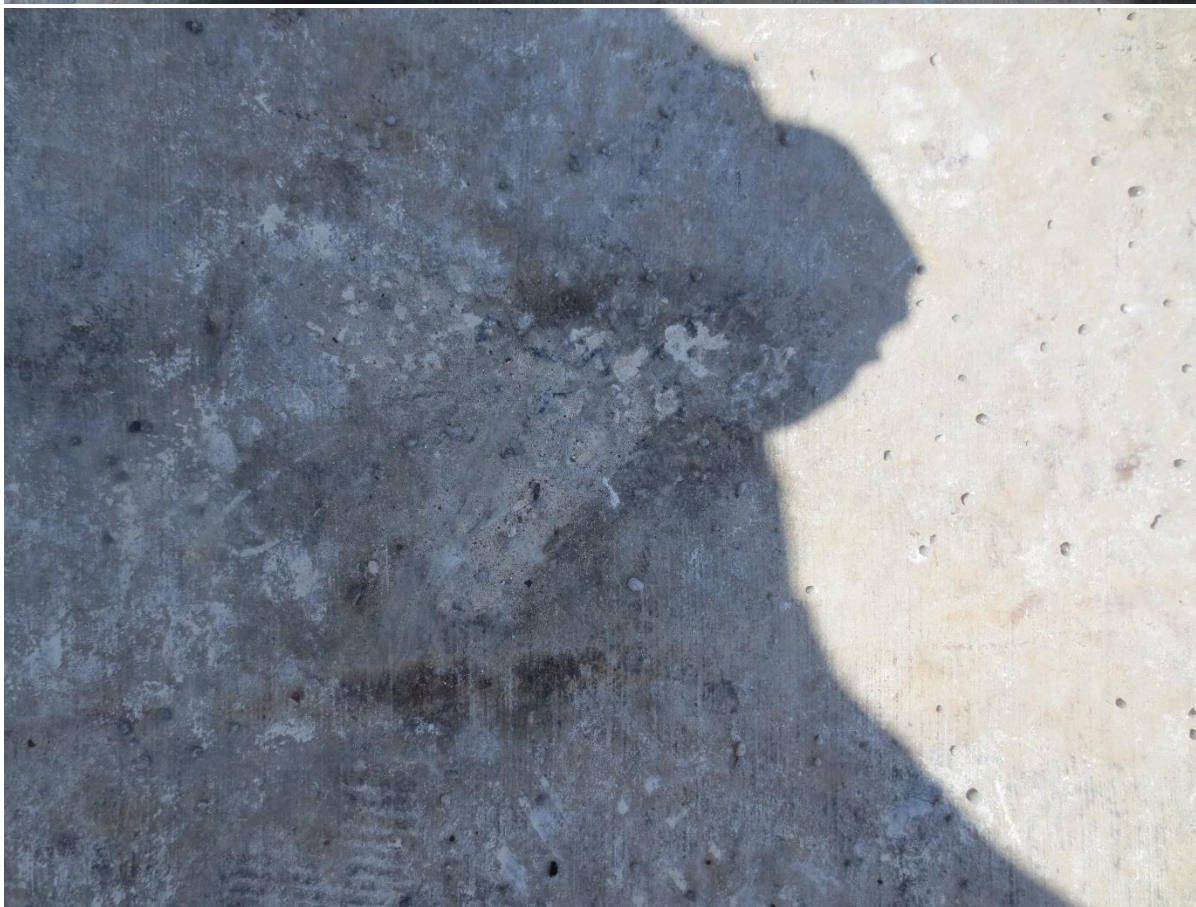
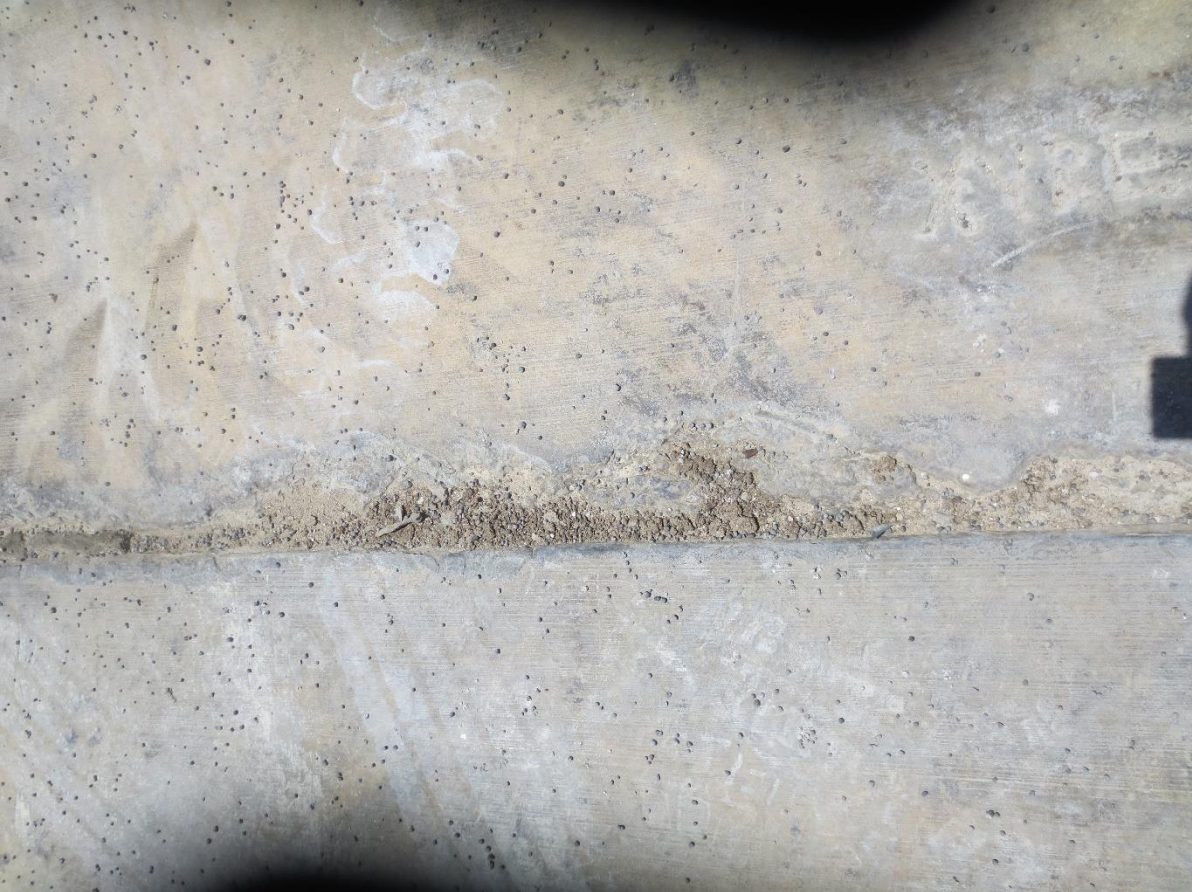
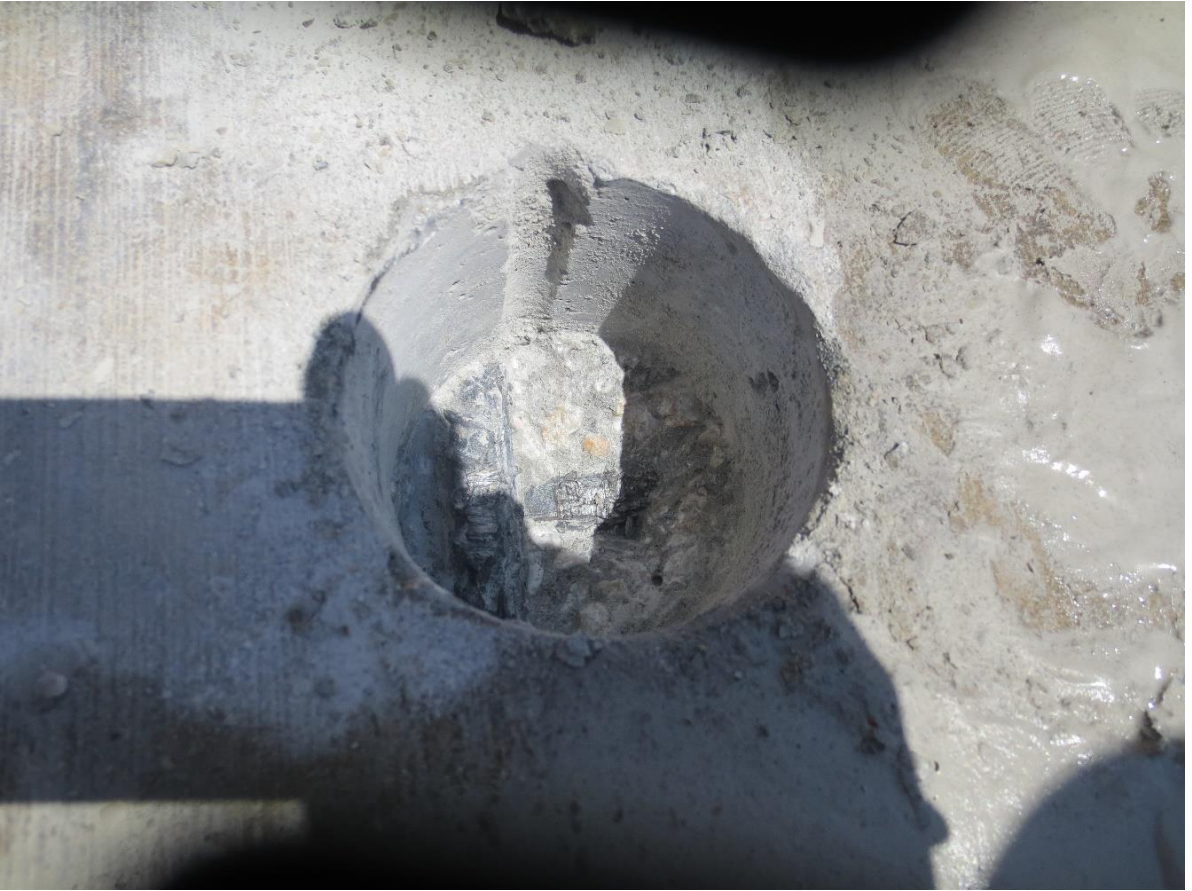
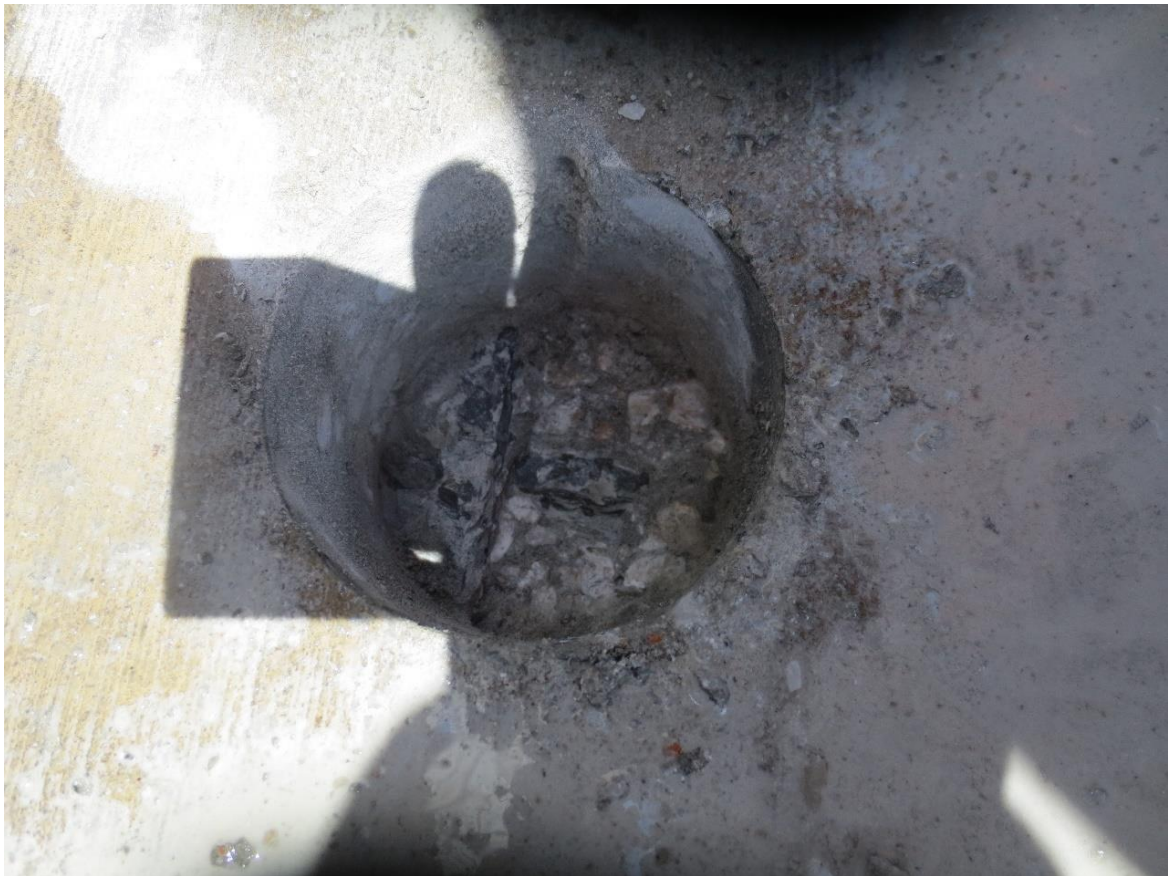
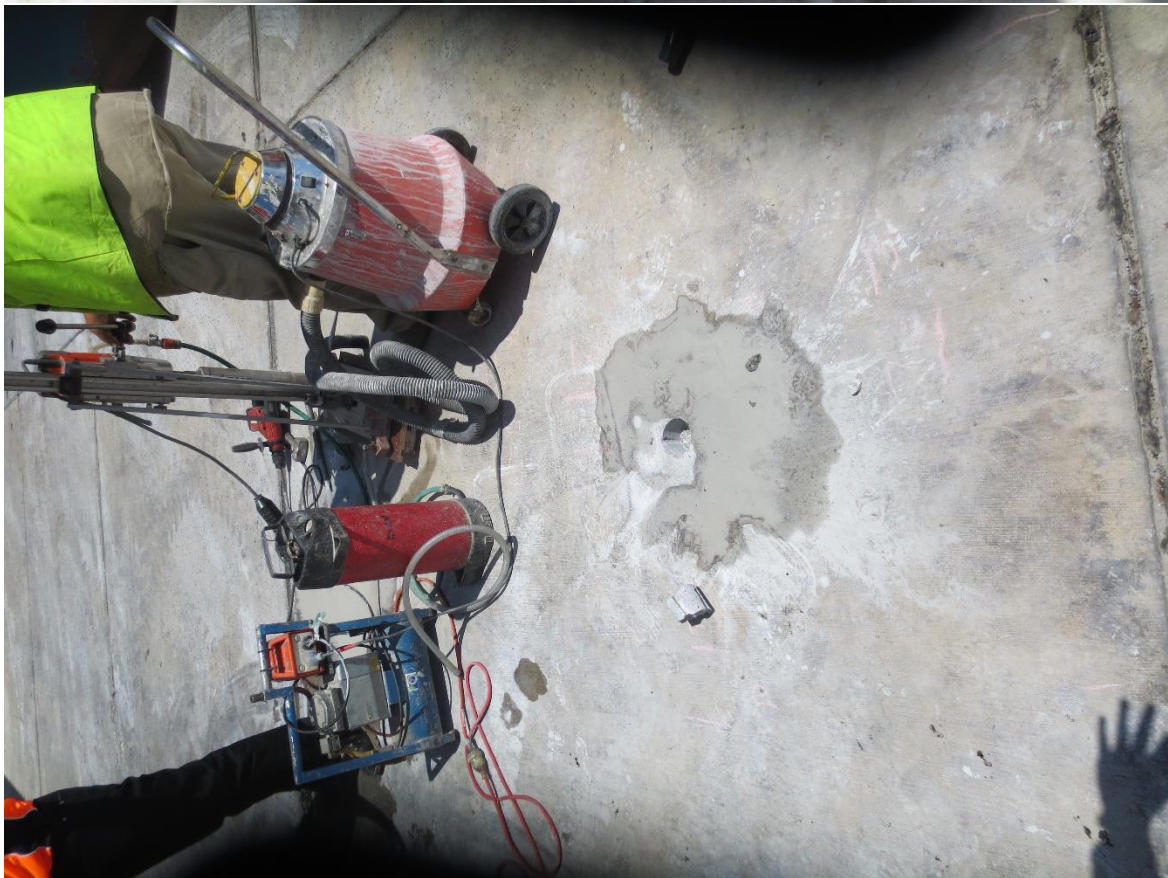
PHOTOS OF SURVEY

Visual inspection of the Xypex slab indicated that there was very little delamination and surface damage. The concrete surface showed minor wear on the edges of the panel as well as small amounts of general wear. There were no visible cracks, spalling or other damage to the panel. Pictures from the Visual Inspection can be found in appendix B attached.
