**51st Annual Meeting of the Civil Engineering Society of Japan
(September 1996)**

Repairing of Heavily Cracked Reinforced Concrete Bridge Deck Slab From Underside

Shigemichi Mori, *The Construction Bureau of Chubu District, The Ministry of Construction*
Yuzuru Kuramoto, Minoru Emilio Takagi, *Japan Xypex Inc.*
Moichi Horie, *Aichi Institute of Technology*
Shushi Tanimoto, *Tenox Inc.*

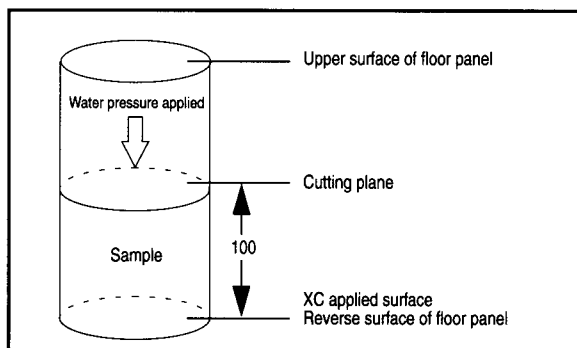
Figure 1: Test sample for water blocking ability

The samples for testing the water blocking ability were made by cutting the extracted cylindrical core at its half line as shown in Figure 1. The lower part of the core, where the cracks are more pronounced, was used for testing. Pressurized water was applied on the upper surface of this test specimen and water flow was recorded. See Figure 2.

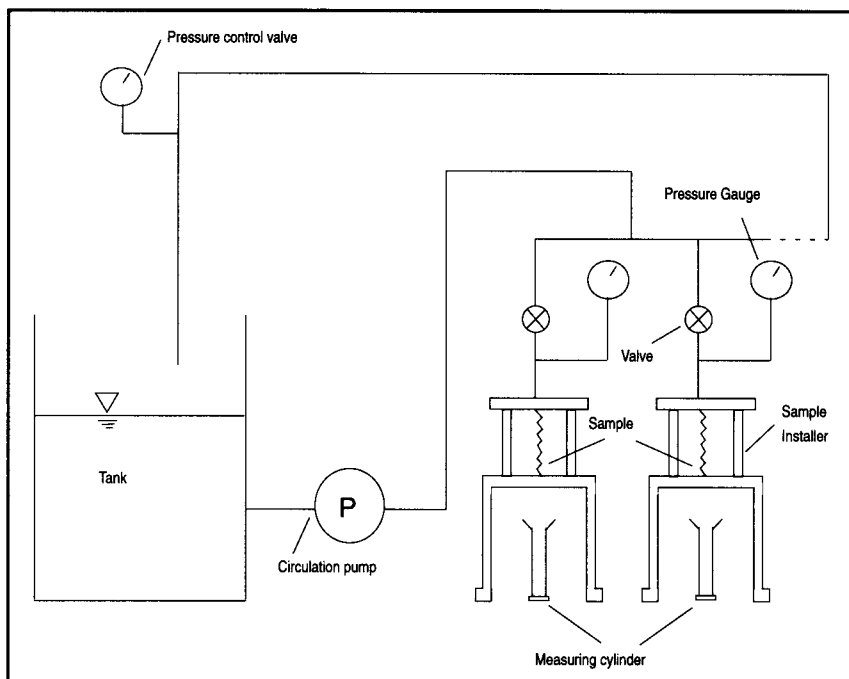
Figure 2: Conceptual structure of the water leak test

- 1) Specifications of the test:
 1. Water leak test: "Output method"
 2. Water pressure: 2 kgf/cm²
 3. Testing time: 16 hours
 4. Number of samples tested: 6 each

Figure 2 shows the conceptual structure of the water leak test.

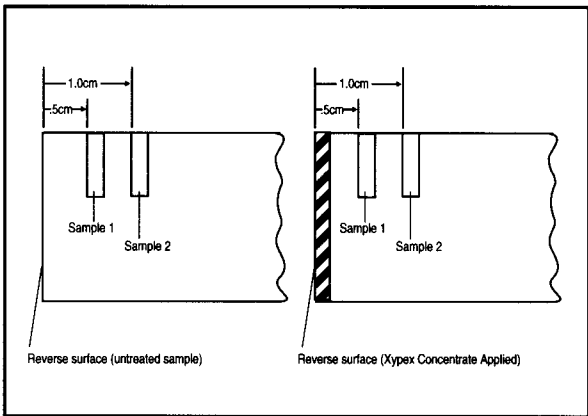
Figure 4: Location for extracting the SEM observation samples.

Test samples for the Scanning Electron Microscopy (SEM) were taken at locations 5 to 6 cm and 10 to 11 cm from the surface on which Xypex Concentrate was applied. See Figure 4. The width of cracks in these sub-samples were within the range of 0.08 to 0.18 mm. Structural observations were recorded.

- 1) The extraction procedure for the test specimens for SEM observation is shown in Figure 4.
